AFWAL-TR-84-2048

DAMAGE CAUSED TO POLYURETHANE FOAMS BY AGING,
SIMULATED SUNLIGHT EXPOSURE, HEAT AND FIRE

Leo Parts
MONSANTO RESEARCH CORPORATION
DAYTON LABORATORY
1515 NICHOLAS RD.
DAYTON, OHIO 45407

JULY 1984

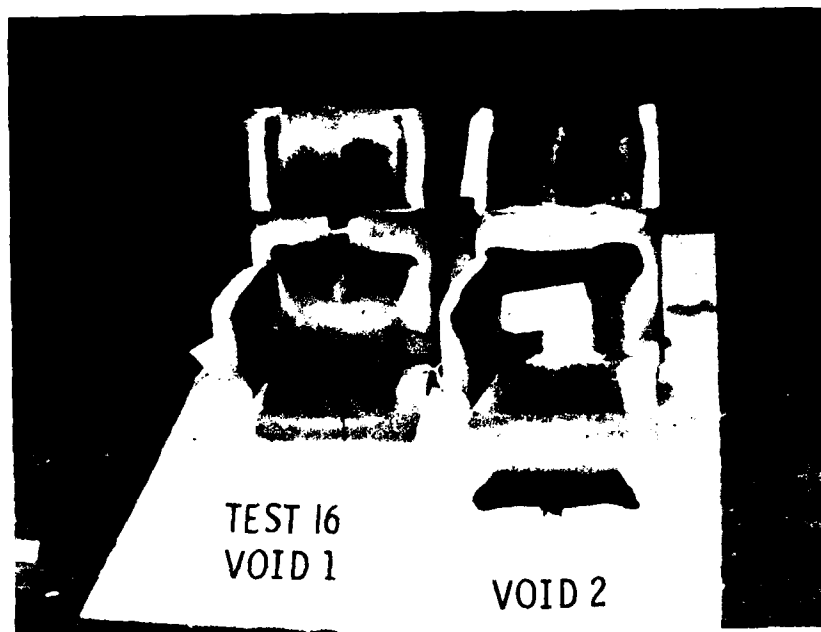
Figure 21. Red foam damage pattern, Test 16.

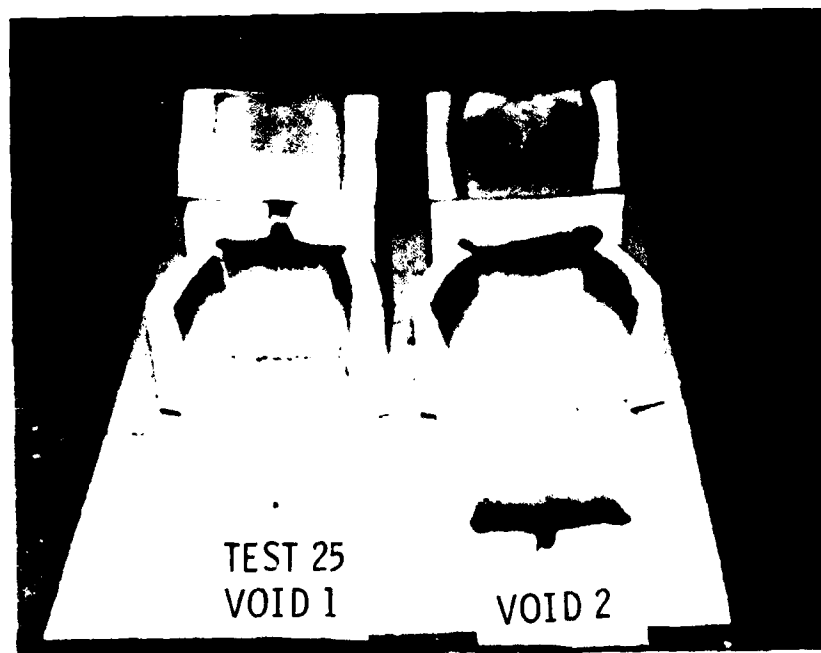
Figure 22. Yellow foam damage pattern, Test 25.

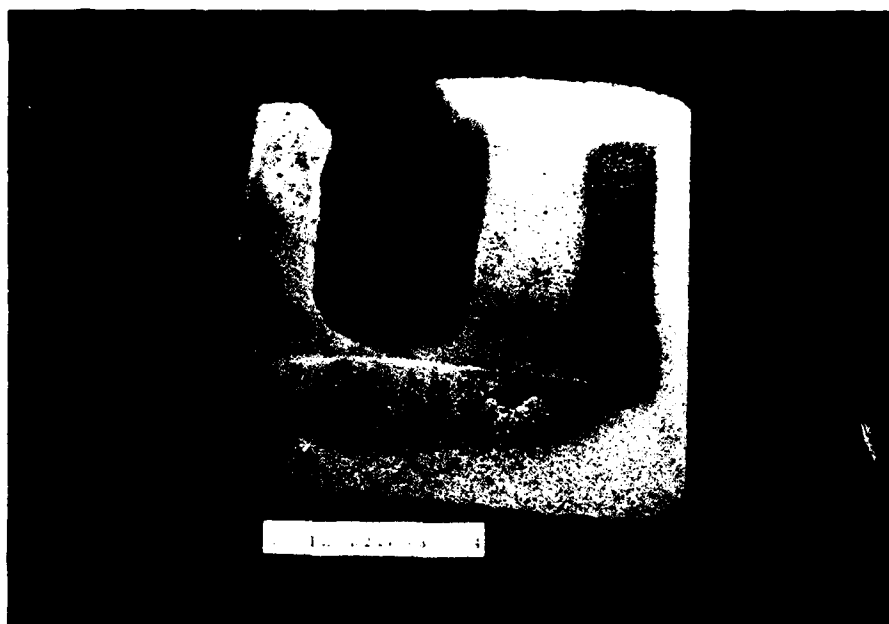
All three specimens (Specimens 1-3; see Figures 28-30) exhibited surface degradation in an irregular pattern. Pieces of char adhered to the affected surface. In most of the affected areas, foam damage did not extend deep below the surface (see Figure 31). Consequently, it is concluded that this damage was caused by burning of the foam.

Figure 28. Fuel vent tank foam, left half,
A/C 78-717 (Specimen No. 1).

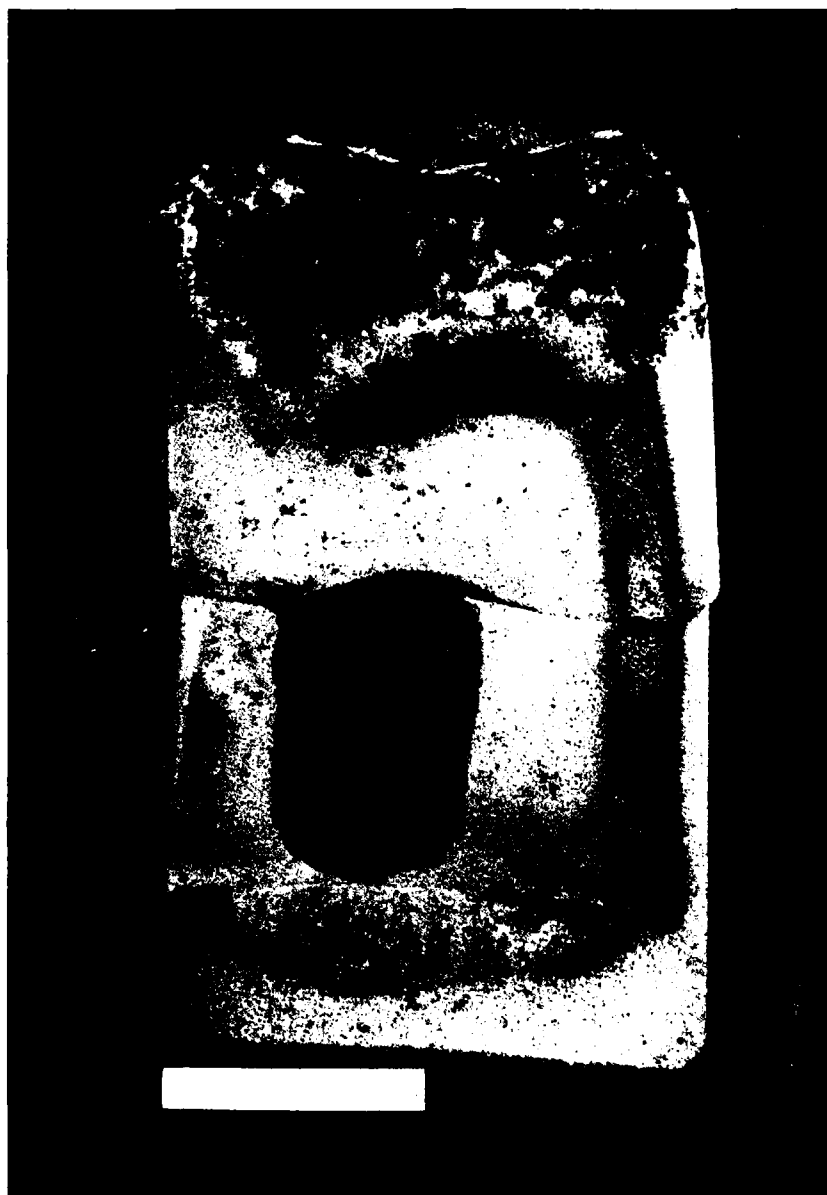
Figure 32. Two halves of fuel vent tank foam from A/C 78-717 (Specimens Nos. 1 and 2) placed together.

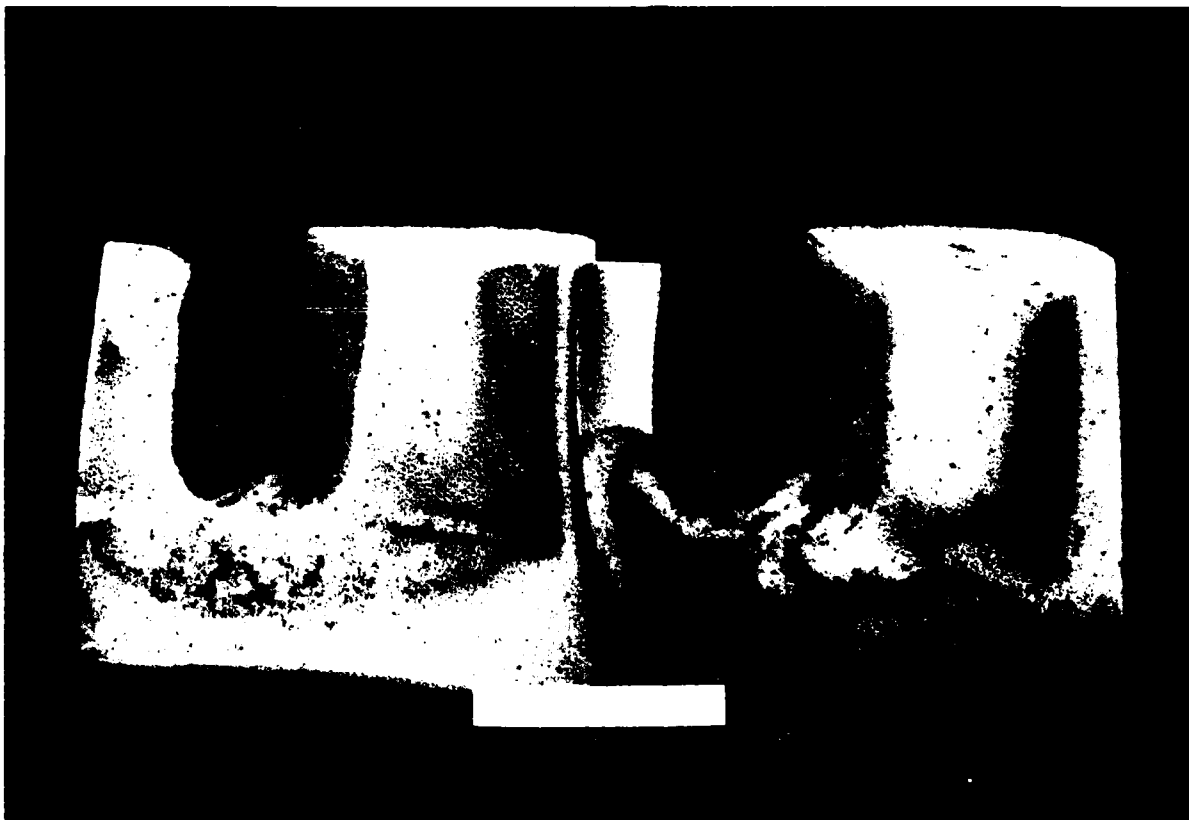
Figure 34. Left halves of fuel tank foam
from A/C-s 78-704 and 78-717.

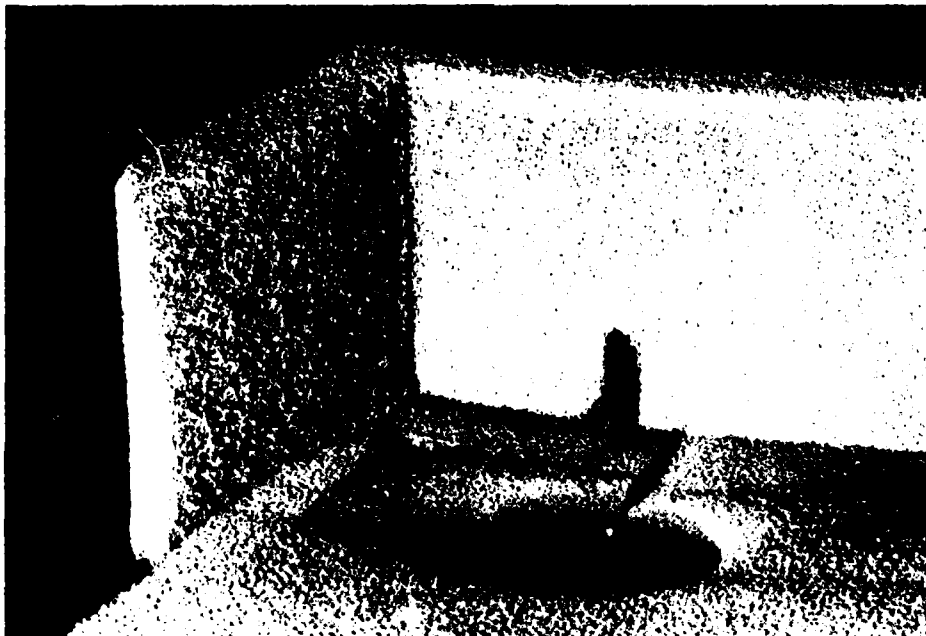
The inside surface of the depicted assembly of void filling foam (Specimen No. 4; see Figures 35 to 37) had been exposed to flash fire(s) of short duration. The surfaces of foam pieces were singed. The damage did not extend into the foam.

Figure 36. Fire-damaged surface of fuel
tank foam (Specimen No. 4).

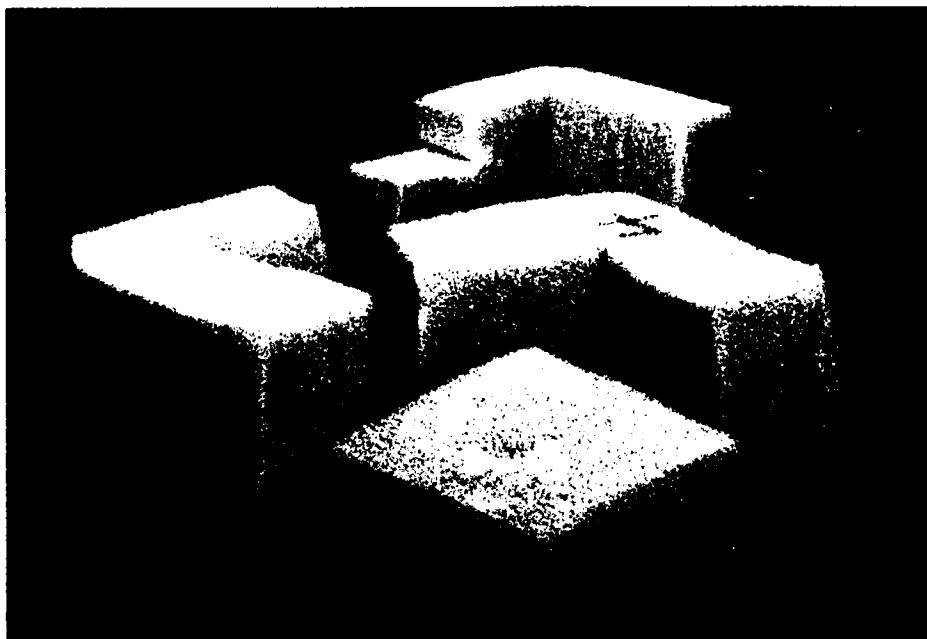
Figure 38. Foam pieces from the wing tank of A/C 78-717 (Specimens Nos. 5-8).

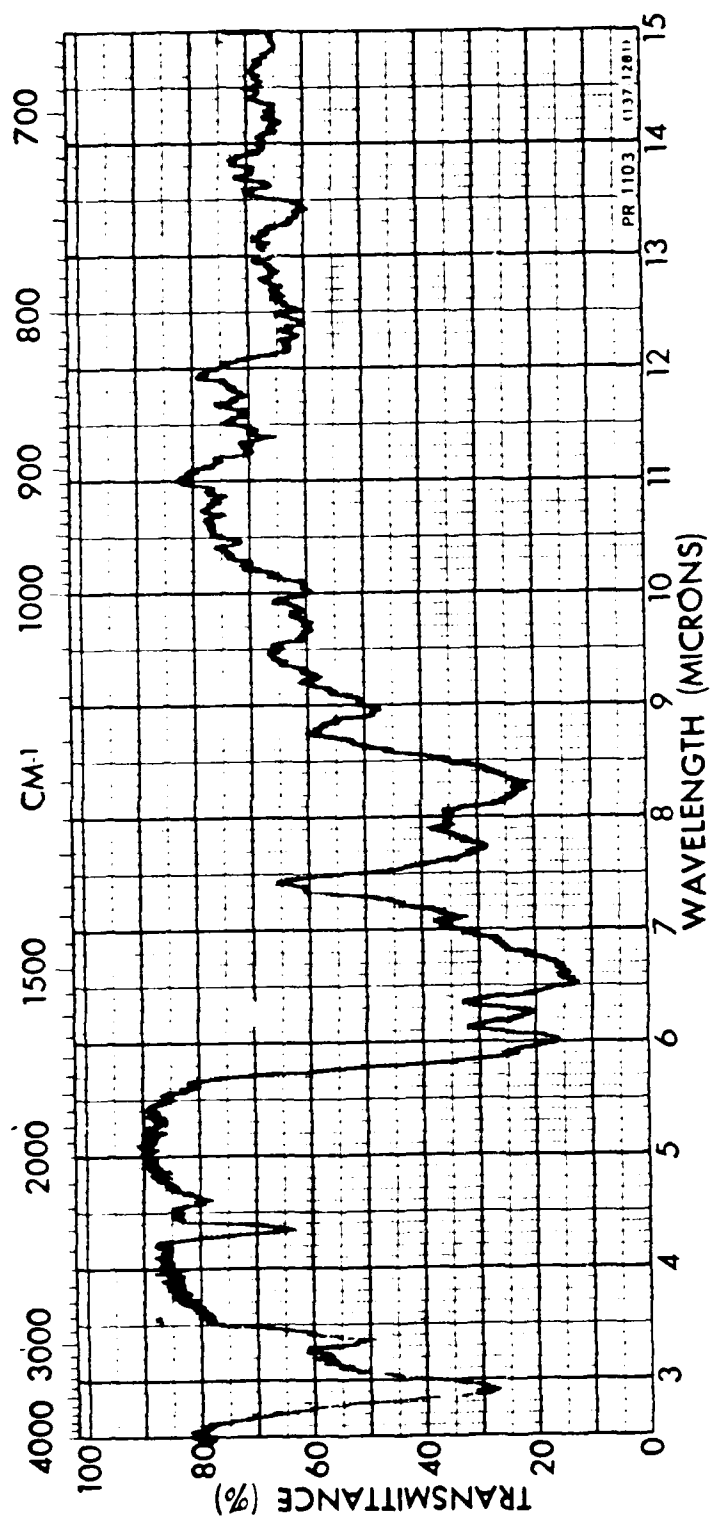
Figure 40. Infrared spectrum of wipings from vent mast of A/C 78-704 (Specimen No. 11; in KBr matrix).
